Case Study: CH-1697

3D TRASAR™ TECHNOLOGY FOR CRUDE OVERHEAD SYSTEMS IDENTIFIES ROOT CAUSE OF LOW PH EVENTS

Case Study: Refining Process Treatment

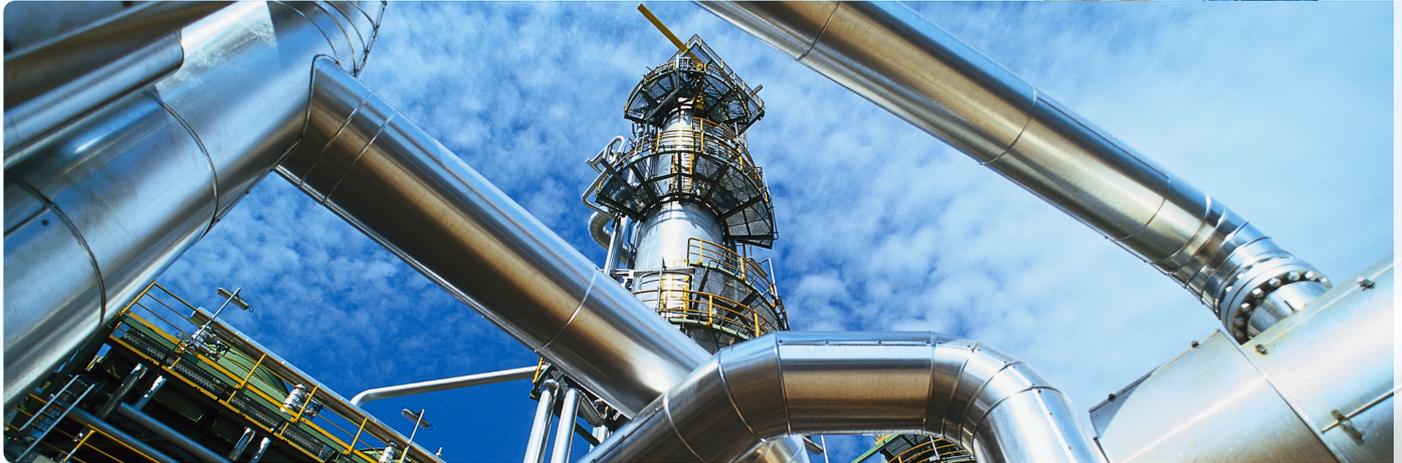
Chloride spikes and pH drops became noticeable when water make in the hot accumulator fell, indicating reduced tolerance for process variability. In the evening, the 3D TRASAR unit for COS routinely alarmed that the pH dropped 0.3 pH units and chloride spiked from 50 PPM to 100+ PPM. Nalco Champion and the customer found what appeared to be a short duration upset condition occurring on one train of desalters approximately 30 - 40 minutes before each pH/Chloride event (Figure 1).

mechanical survey performed on the desalter identified mud wash piping and operational differences between desalter trains as the root cause for the pressure fluctuations. Piping and operational differences could not be changed while continuing to run the unit, but the caustic pump was repaired to ensure caustic injection during mud wash, thereby eliminating the pH/chloride nightly events.

As a consequence of these findings, the mud wash piping arrangement was changed in the next turnaround to eliminate the pressure interference, and the overhead condenser bundles were pulled and cleaned in an effort to improve first stage water condensation. Additional mechanical and operational changes were made to minimize corrosion events monitored by the 3D TRASAR technology for COS.

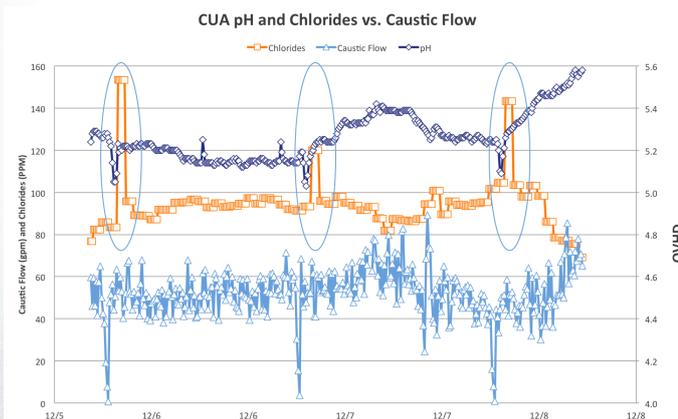
Figure 1

Further investigation showed that these events aligned with desalter mud washes where, in addition to short term pressure fluctuations, the caustic flow dropped to 0.0 GPM for 30 to 40 minutes - the same duration as the atmospheric overhead events identified by the 3D TRASAR technology for COS (denoted by the blue circles in Figure 1). The caustic flow rate reduction was a result of pump mechanical issues which stopped the caustic flow during the short term pressure fluctuations. A
